Owners And O&M

By **Wayne Webster**, Member ASHRAE

To ASHRAE members, O&M means operations and maintenance, but it implies owning and managing to most real estate professionals. The two disciplines overlap and complement each other. The following article demonstrates the importance and value of a technically trained owner who also fills the role of facilities engineer, and provides direction to operations and maintenance staff, and service contractors.

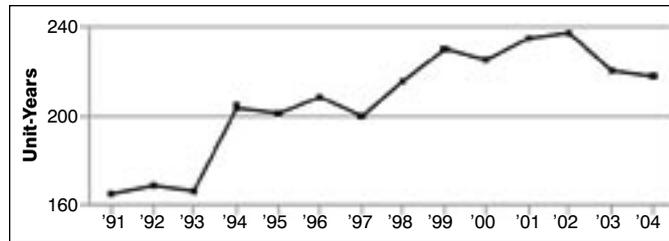
Figure 1: Occupancy-residents for the Princess Towers.

- Occupancy has increased more than 40% (Figure 1);
- The total utility costs are up 30% (Figure 2);
- Natural gas costs vary from 40% to 56%, electricity are from 29% to 39%, and water from 11% to 21% (Figure 3);
- The electrical consumption dropped 20% for several years but recently increased to the level recorded in 1991. It is considered that this is due to increased occupancy (note that both dropped in 2003 & 2004), and the increased number and use of computers which are standard equipment with today's college students (Figure 4);

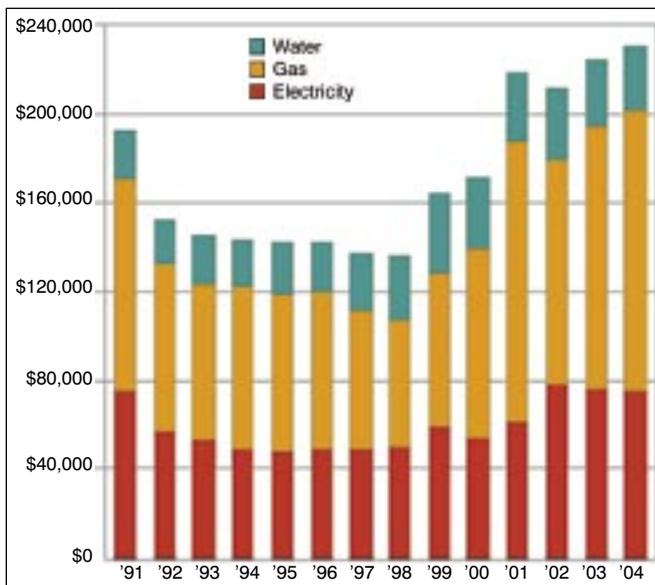
Figure 2 (left): Annual utility costs. Figure 3 (right): Utility cost percentages.

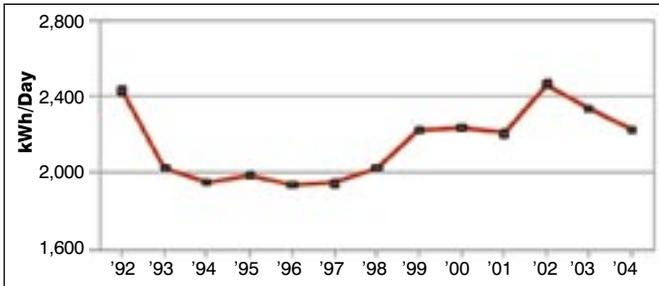
Figure 4 (left): Electrical average consumption. Figure 5 (right): Electrical average demand.

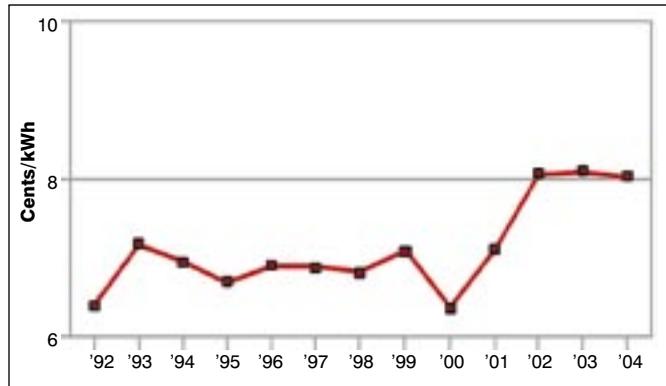
Figure 6: Electrical unit cost.

- The unit electrical cost has increased almost 30% (Figure 6);

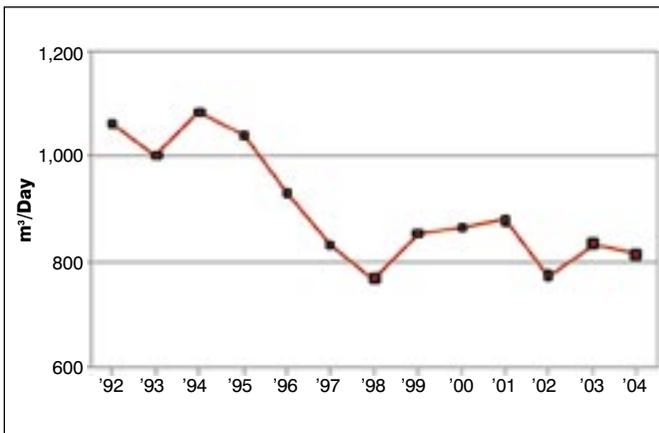
Figure 7 (left): Natural gas consumption. Figure 8 (right): Natural gas unit cost.

- The natural gas (space and domestic water heating) has been at or less than 80% of the 1992 level (Figure 7);

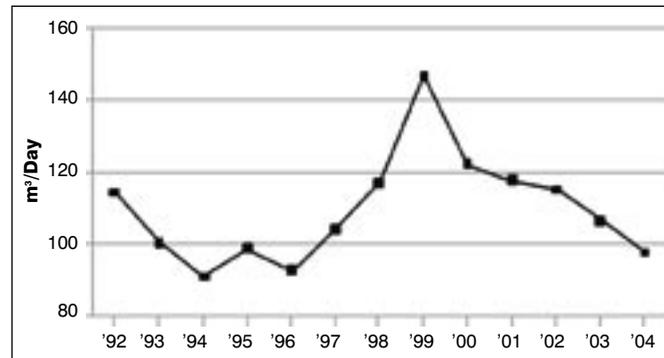
Figure 9: Water consumption.

- Water consumption peaked in the late 1990s, apparently due to faulty flow control valves and potentially slow response to leaks (Figure 9);

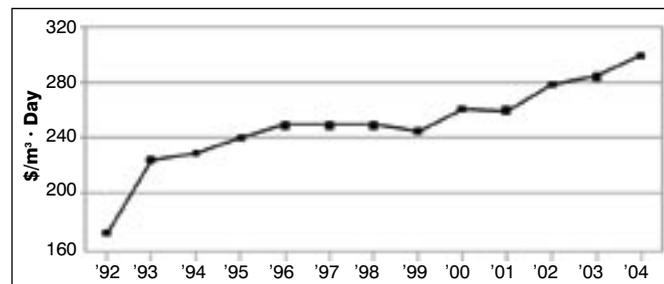
Figure 10: Water unit cost.

- The unit cost of water has increased 65% (Figure 10); and
